**Phase 1 Environmental Assessment  
Aeroflight Executive Incorporated  
King County International Airport  
King County, Washington**

**March 17, 1998**

AGI Project No. 14,309.454

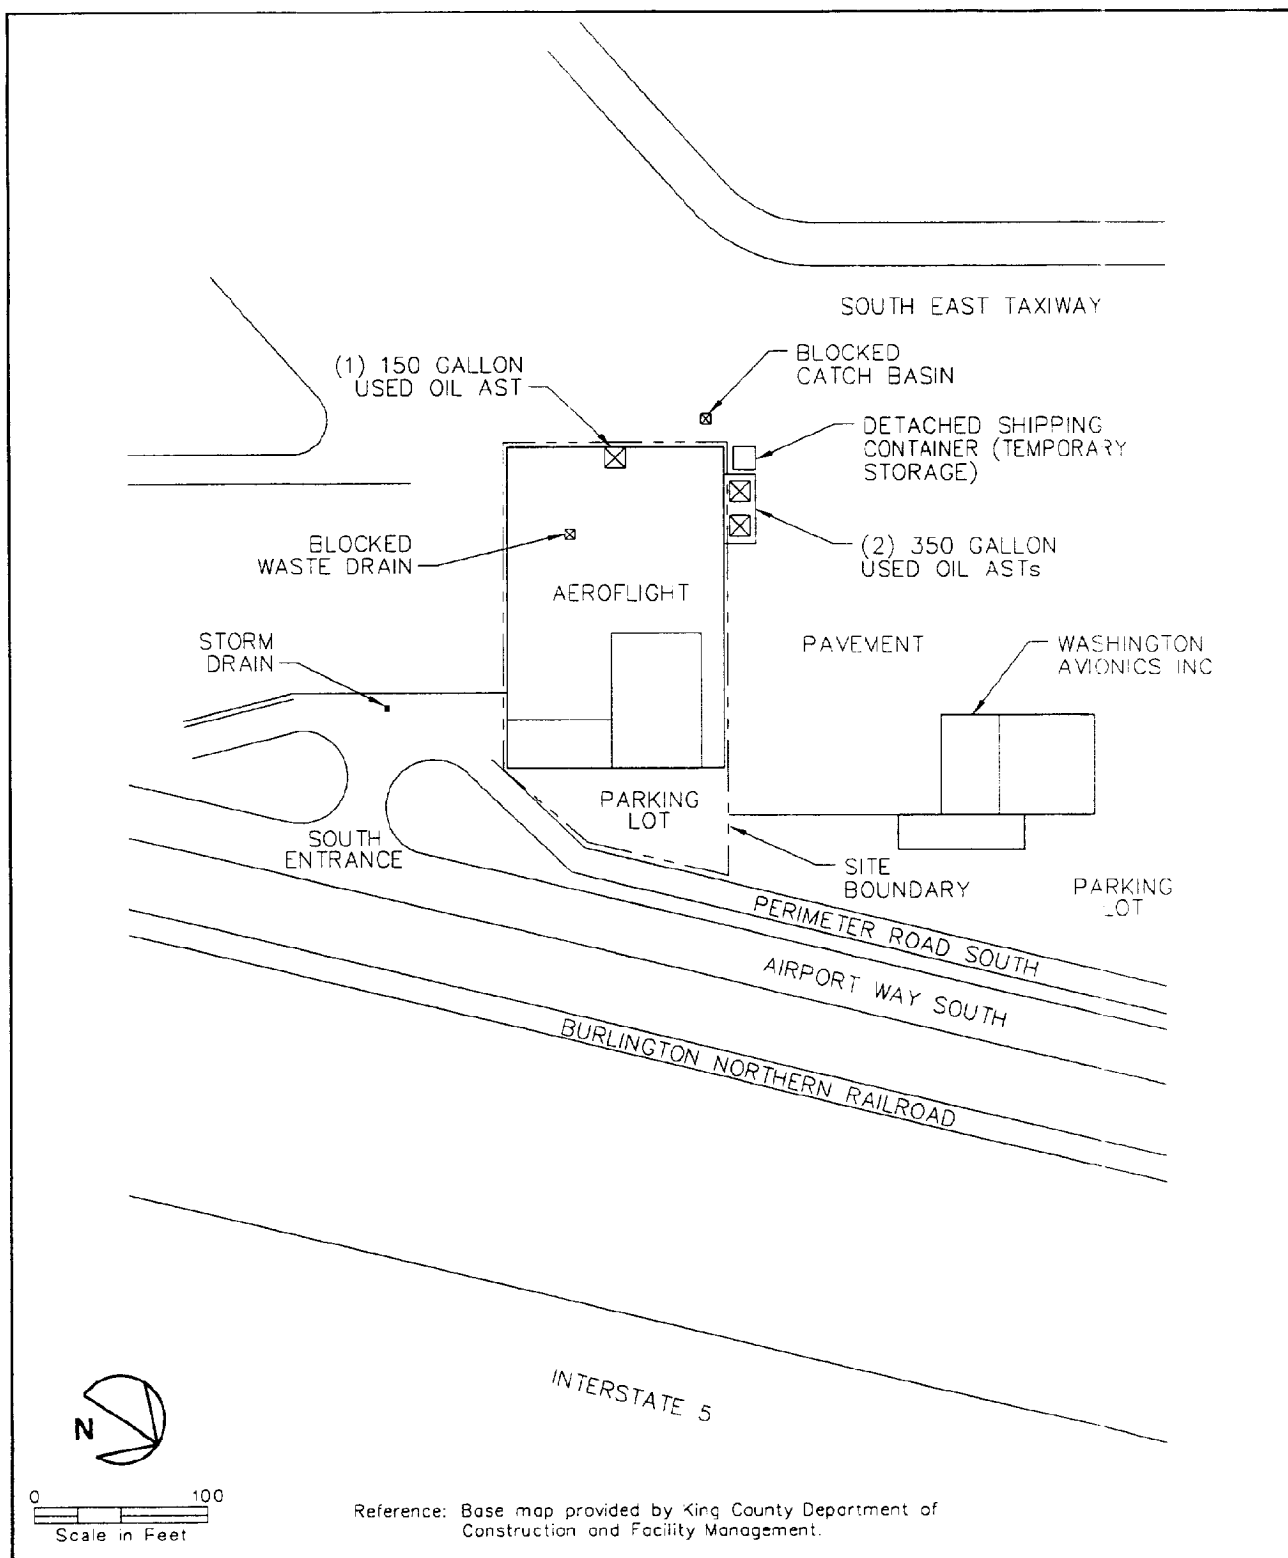
Pertinent site features are shown on Figure 2 and in Appendix A. The site address is 8555 Perimeter Road South with the property being accessible from Perimeter Road South. The Aeroflight facility is comprised of a prefabricated aluminum building with a parking lot located on the east. The building is comprised of two floors of offices and a metal hangar. Improvements have been made to the offices including: reallocating upstairs office space, adding an upstairs balcony and stairs to the north and west sides, and installing an additional downstairs bathroom.

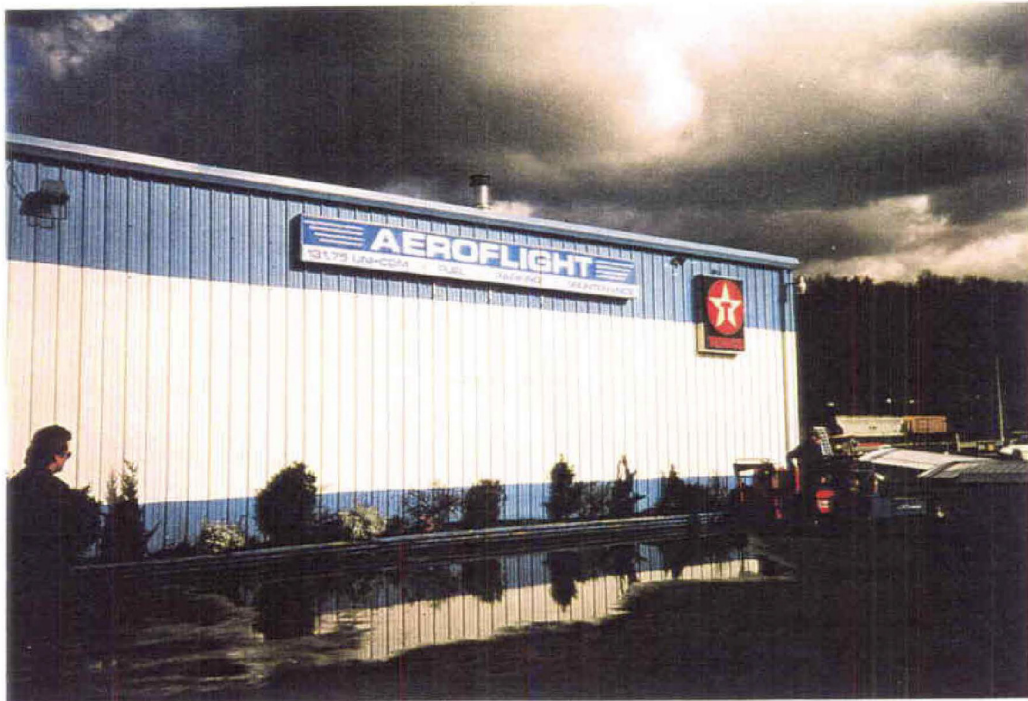
View of Aeroflight building.

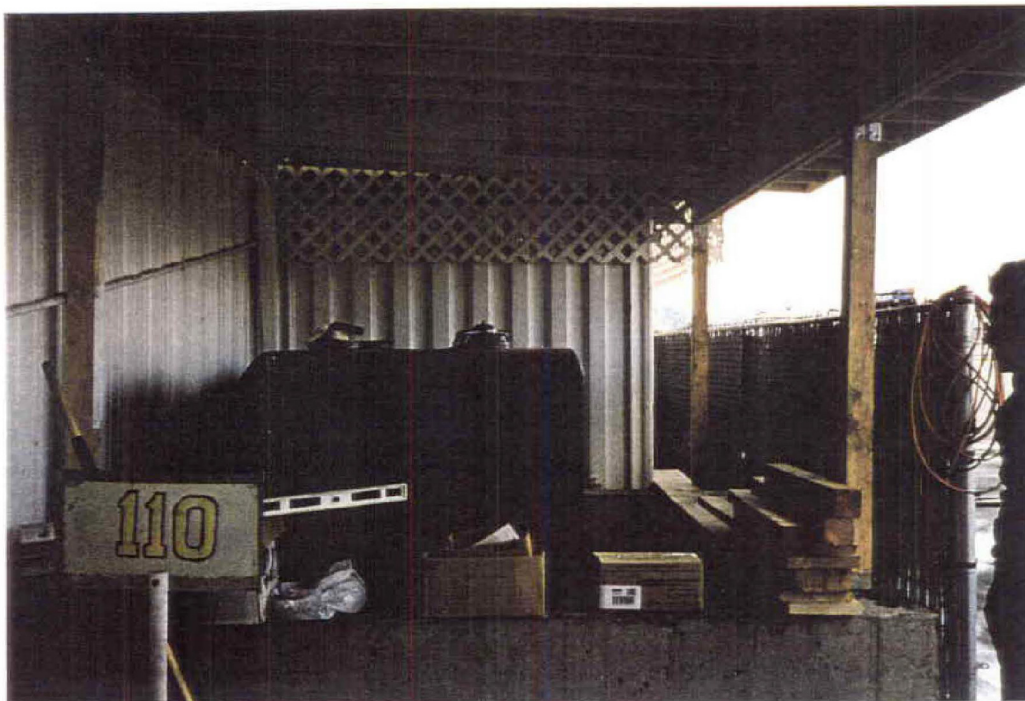
During the site reconnaissance EcoChem personnel did not observe any evidence of underground storage tanks. Two 350-gallon above ground used oil storage tanks with secondary containment are located under a covered area on the north side of the building (Appendix A). One 150-gallon above-ground used oil tank is located inside the maintenance area. The 150-gallon above ground tank is used to fuel a heater for the inside of the hangar during the colder months of the year. Historically, the Aeroflight building has been heated by electrical heat and has supplemented this by burning used oil in the maintenance area. Fuel is transferred via an inline system from the 350-gallon above ground used oil tanks and filtered into the 150-gallon above-ground used oil tank. Used oil is also poured directly (using a funnel) into the 150-gallon tank by mechanics during maintenance and repair operations. The 150- and 350-gallon tanks serving as receptacles for the used oil and the 55-gallon container for used oil filters were not clearly labeled. These containers temporarily store wastes until they are either burned as fuel onsite or are recycled offsite.

Two 350 gallon above ground tanks.
